A Living Community: St. Joan of Arc Chapel

Marquette University
Milwaukee, Wisconsin

Spring 2020

Historic Structure Report Summary

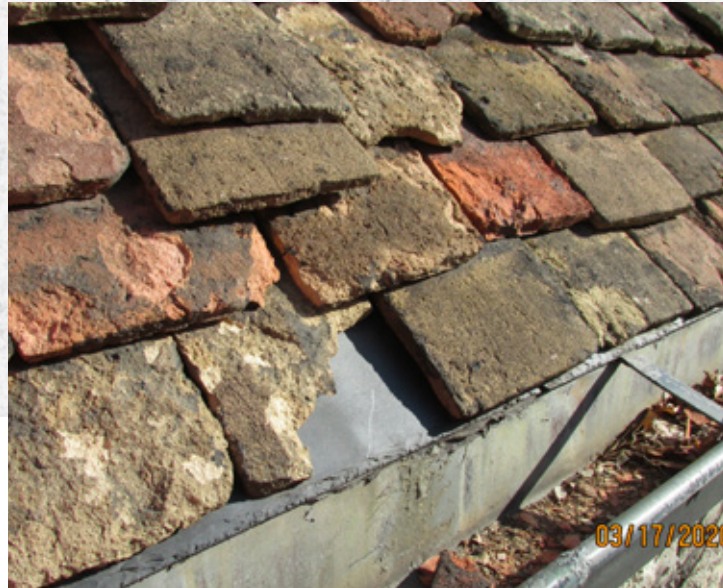
Approximately 25 - 30% of the historic clay roof tiles are deteriorated and would not survive removal and reuse.

The historic roof of the chapel is in need of repair. Many original historic terra cotta clay tiles are deteriorated, broken, or missing. For any repair approximately 25 – 30 % would not survive removal and reuse. Additionally, the felt roof underlayment at the spillway areas is deteriorated and the same is suspected in the field at broken tiles.

Provide an entirely new roof system while also preserving the original character and historic material to the extent possible - a blend of historic and new tile. The work will include upsized gutters and additional downspouts to address the existing overburdened drainage system.

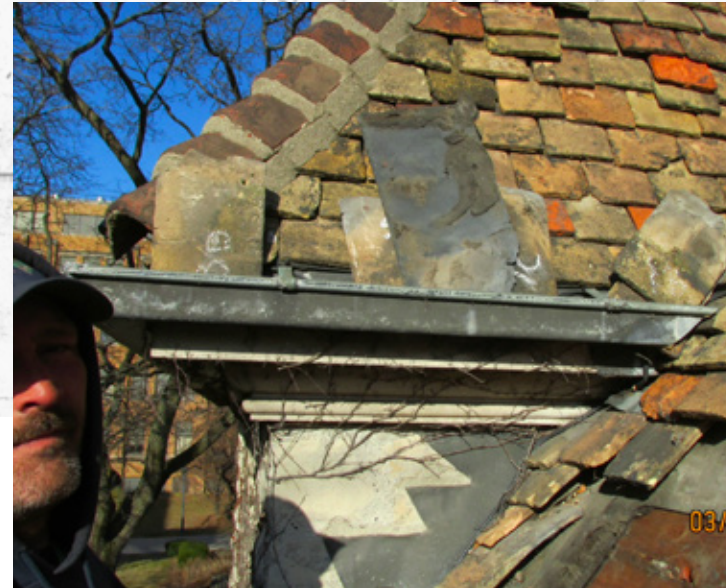
A preliminary roof tile inspection was conducted at the lower west corner on the south slope of the nave.

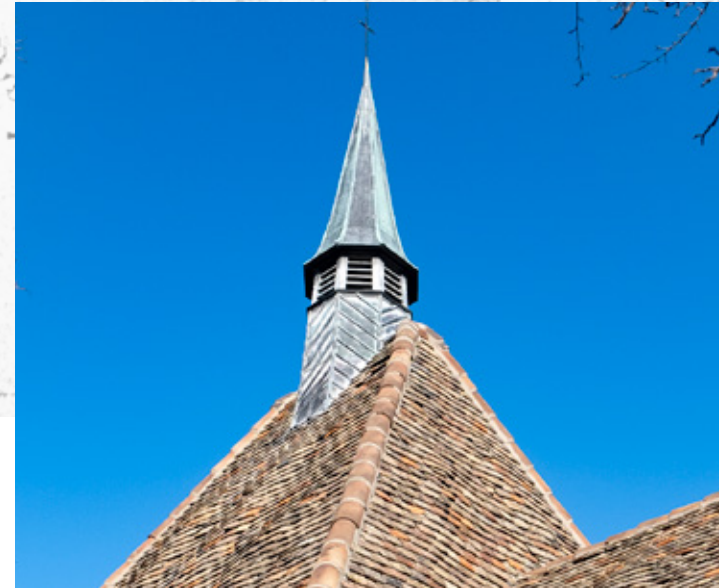
Solder joints and copper roofing of the historic are in need of repair and reinforcement. The solid roof deck and closed floor of the louvered area need opening for installation of the ventilation shaft.

Inspection of the historic steeple also revealed that solder joints and copper roofing has deteriorated over time, creating potential for water intrusion and damage.

Temporary removal of the steeple will facilitate installation of the ventilation shaft and provide an opportunity to repair failed solder joints.

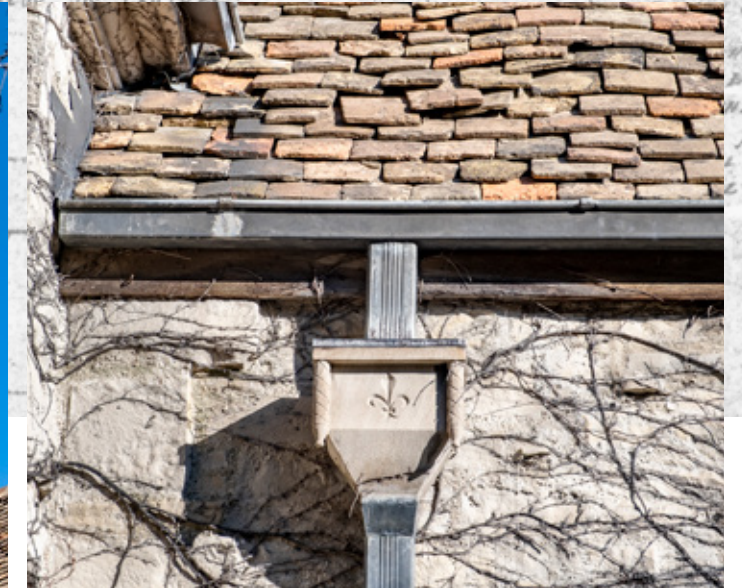
Gutters and downspouts are also in need of improvement to adequately drain water away from the chapel walls and foundation.

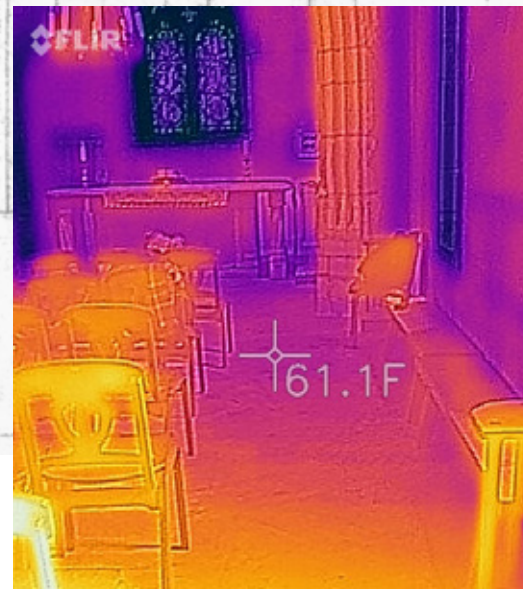
Thermal infrared camera image reveals temperature gradient caused by failed radiant floor heating system in the Chapel nave.

The existing heating system in the Chapel relies on an electric radiant coil below the stone flooring. More than half of this system no longer functions. This imbalance causes large temperature variations within the Chapel - some areas of the floor provide no heat while other areas are measured at temperatures that can cause burns or be uncomfortable to walk/stand on. The altar can also be uncomfortably cold in winter months.

Install a new electric radiant floor heating coil system. This option offers the best solution as it delivers occupant level heating with minimal noise while preserving the historic character of the Chapel. The lack of equipment room space in the Chapel is also a factor in selecting a radiant floor system. Three new radiant heat zones will provide greater control of interior conditions. Improved natural ventilation will be introduced through subtle modifications within the steeple.

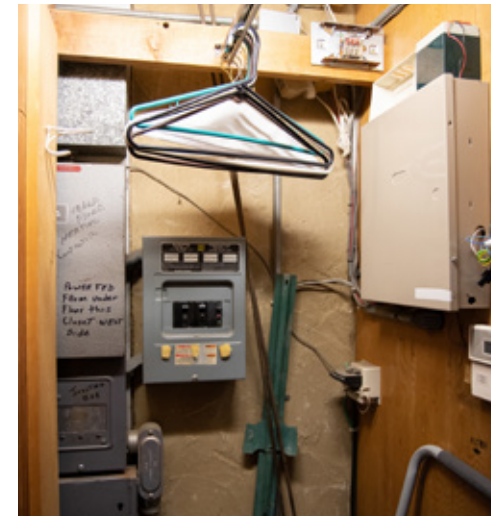
Existing electrical boxes are crowded into the sacristy closet and need upgrades.

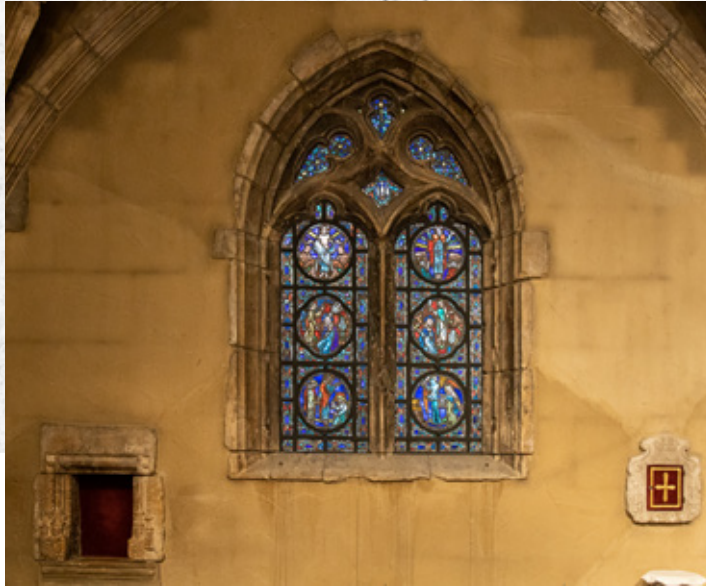
A condition called 'shadowing', which reveals outlines of otherwise hidden concrete block construction, has appeared along walls with exterior exposure. Water staining is visible below the window.

Several contributing factors are adversely affecting the interior plaster finish of the Chapel. Rising damp is visible at the base of the wall resulting from moisture introduced by landscape plantings and mulch beds at the perimeter of the chapel. In the Nave and sanctuary, water staining is visible below window sills and cracks in the plaster are evident at the window heads.

Move planting beds away from exterior chapel walls to better shed water and moisture. Repair cracks at window heads and repaint plaster.

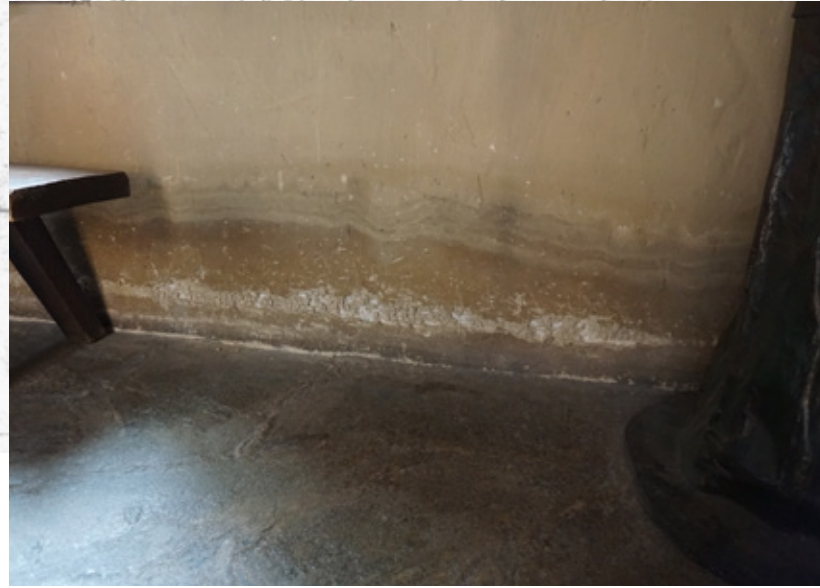
Rising damp is visible at the base of the interior wall resulting from moisture introduced by landscape plantings and mulch beds at the perimeter of the chapel.

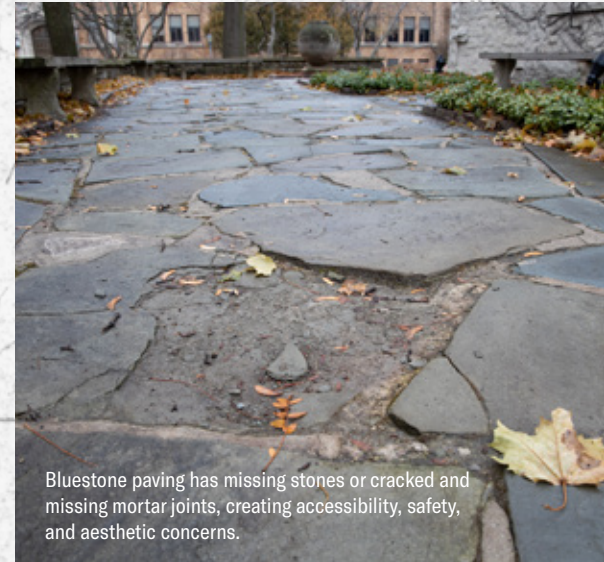
Existing site conditions require modification to improve accessibility, safety, and aesthetics. The bluestone paving around the Chapel and fountain is in poor condition, making the surface a trip hazard and non-compliant with ADA standards. Mortared stone walls need repair and tuck-pointing. There are moisture wicking issues with the vegetation along the perimeter of the chapel. Many trees have structural issues and are showing signs of decline, as well as having leaf disease / fungal problems. Many trees are planted close to the chapel and cause leaf debris and seeds to fall on the roof and into gutters.

Bluestone paving has missing stones or cracked and missing mortar joints, creating accessibility, safety, and aesthetic concerns.

Remove and replace bluestone paving with stone to match the newly installed Grotto paving. Repair mortared stone walls as needed. Replace steps and landings with new reinforced color-matched concrete. Add accessible pathways at the west and north site entries where grade allows for low impact improvements.

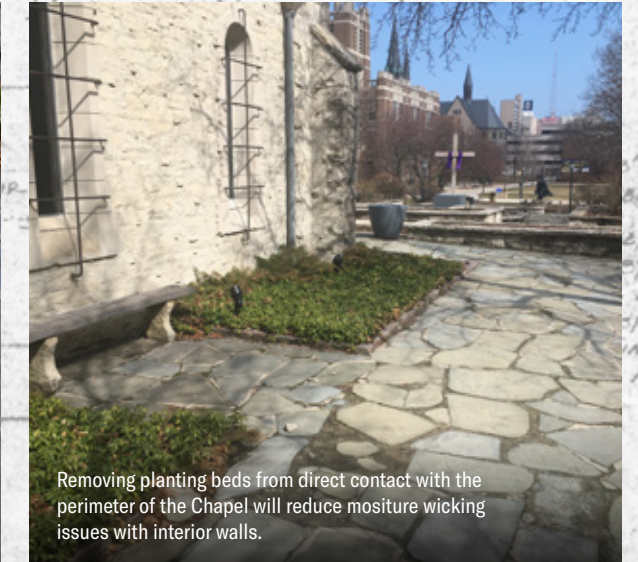
Removing planting beds from direct contact with the perimeter of the Chapel will reduce moisture wicking issues with interior walls.

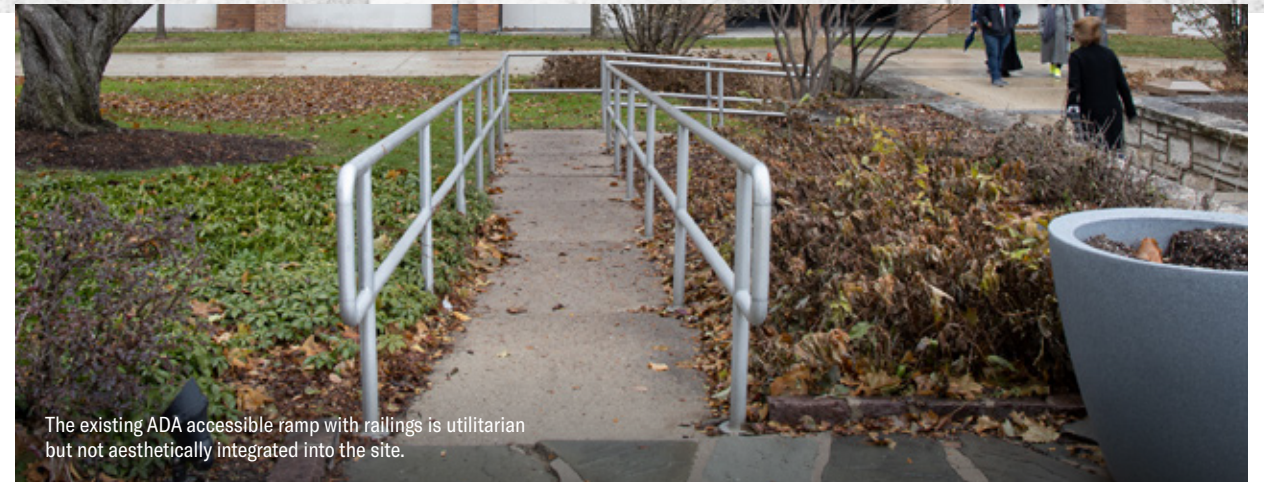
The existing ADA accessible ramp with railings is utilitarian but not aesthetically integrated into the site.

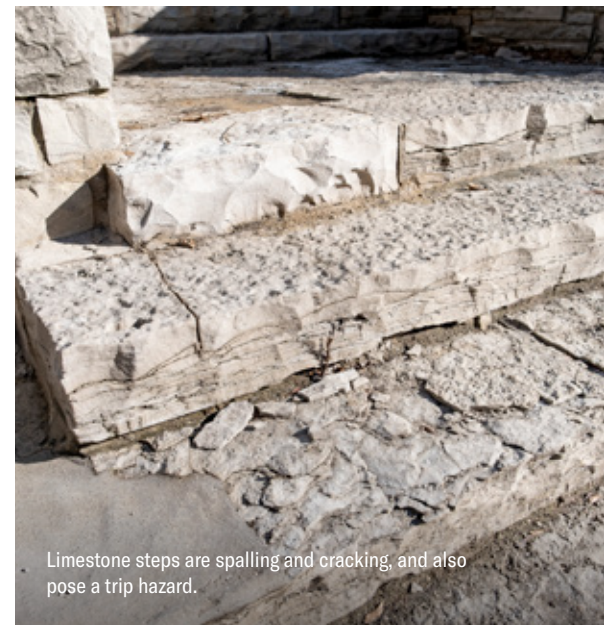
Limestone steps are spalling and cracking, and also pose a trip hazard.

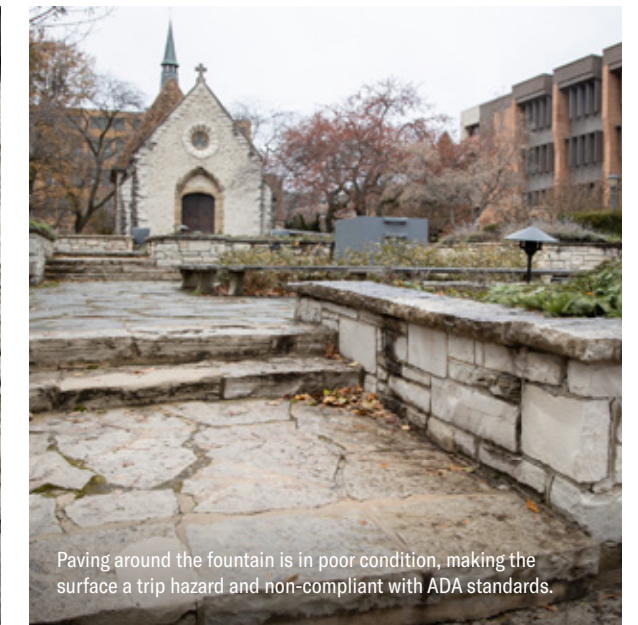
Paving around the fountain is in poor condition, making the surface a trip hazard and non-compliant with ADA standards.
