A Living Community: St. Joan of Arc Chapel

Marquette University
Milwaukee, Wisconsin

Spring 2020

Historic Structure Report Summary

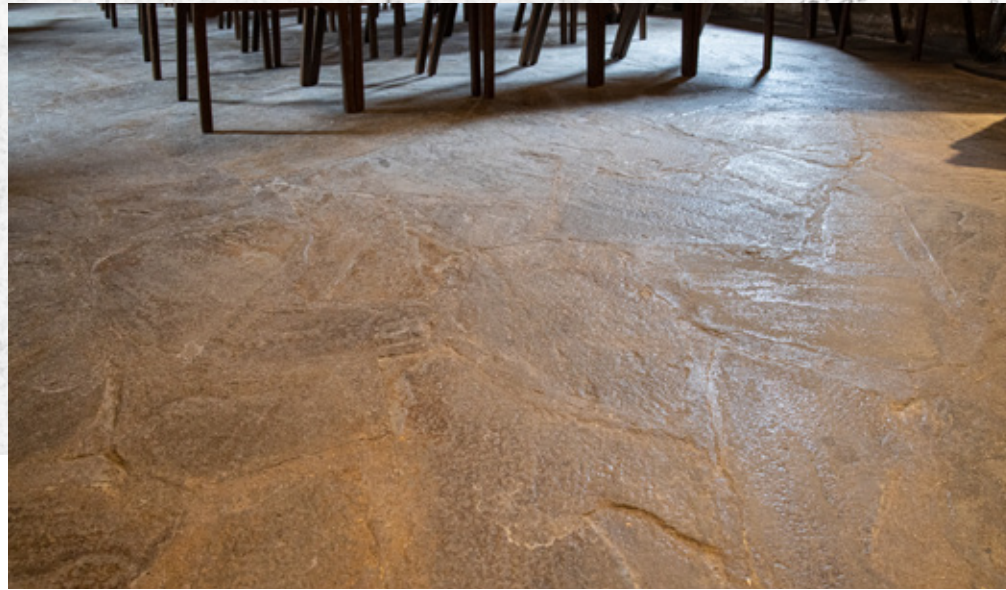
Bluestone flooring installed during the 1966 Chapel reconstruction will be salvaged and reused as part of the proposed new radiant floor heating system.

Install a new electric radiant floor heating coil system. This option offers the best solution as it delivers occupant level heating with minimal noise while preserving the historic character of the Chapel. The lack of equipment room space in the Chapel is also a factor in selecting a radiant floor system. Three new radiant heat zones will provide greater control of interior conditions. Improved natural ventilation will be introduced through subtle modifications within the steeple.

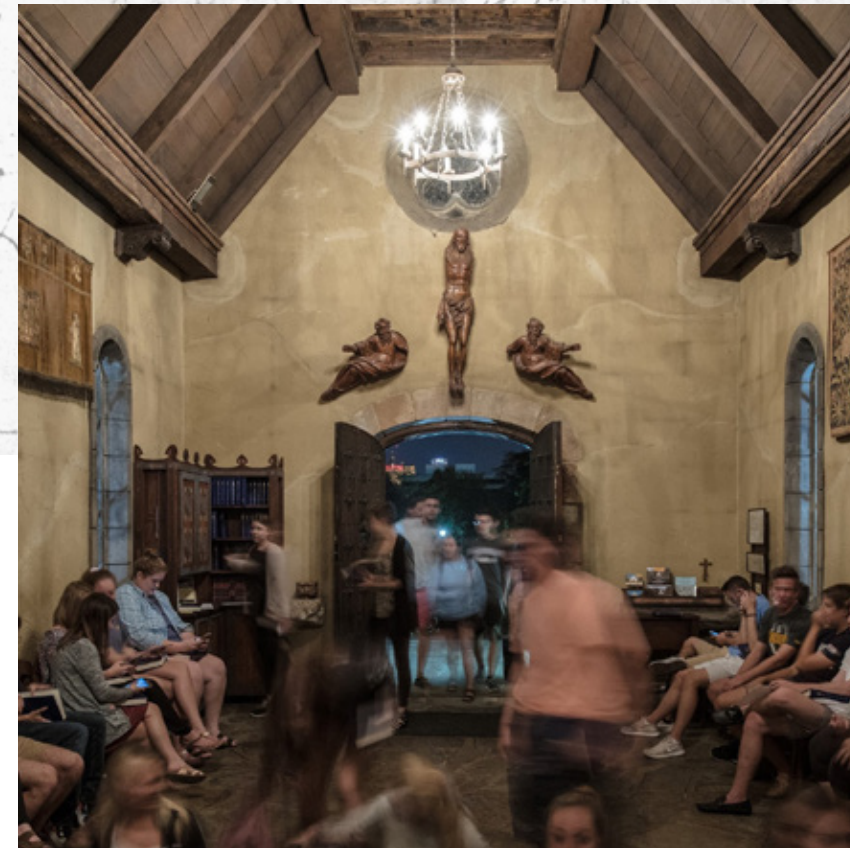
Improving thermal comfort in all seasons for Chapel occupants is an important renovation priority. Supplemental heating strategies can be employed to target improved thermal comfort in the altar and sacristy areas of the Chapel.

The existing heating system in the Chapel relies on an electric radiant coil below the stone flooring. More than half of this system no longer functions. This imbalance causes large temperature variations within the Chapel - some areas of the floor provide no heat while other areas are measured at temperatures that can cause burns or be uncomfortable to walk/stand on. The altar can also be uncomfortably cold in winter months.

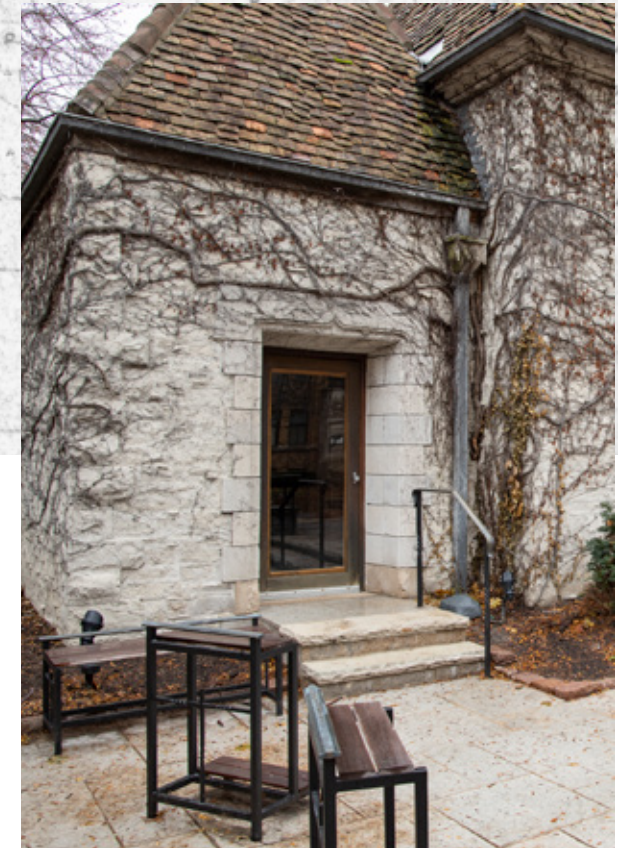
Technology enhancements will provide improved Chapel security and access control.

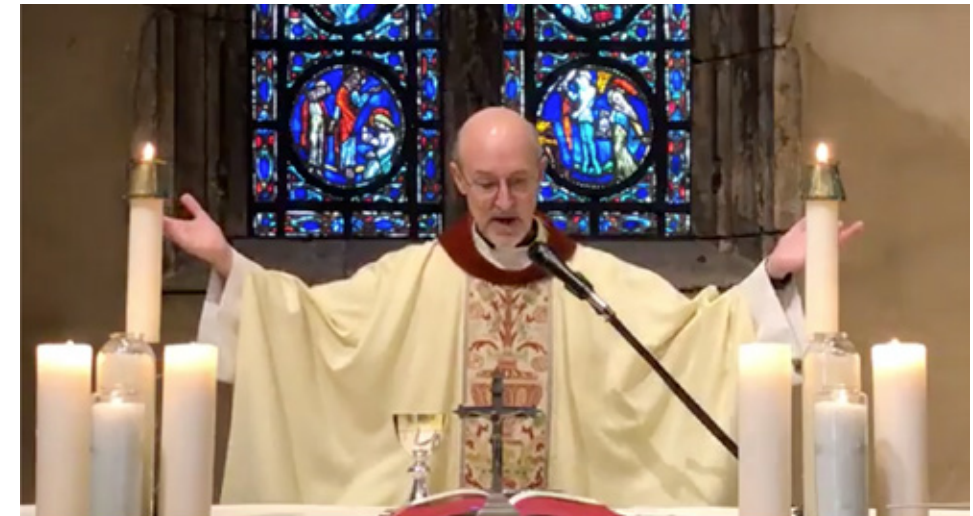
Technology infrastructure can be added to allow remote, live-stream of Chapel services and events.

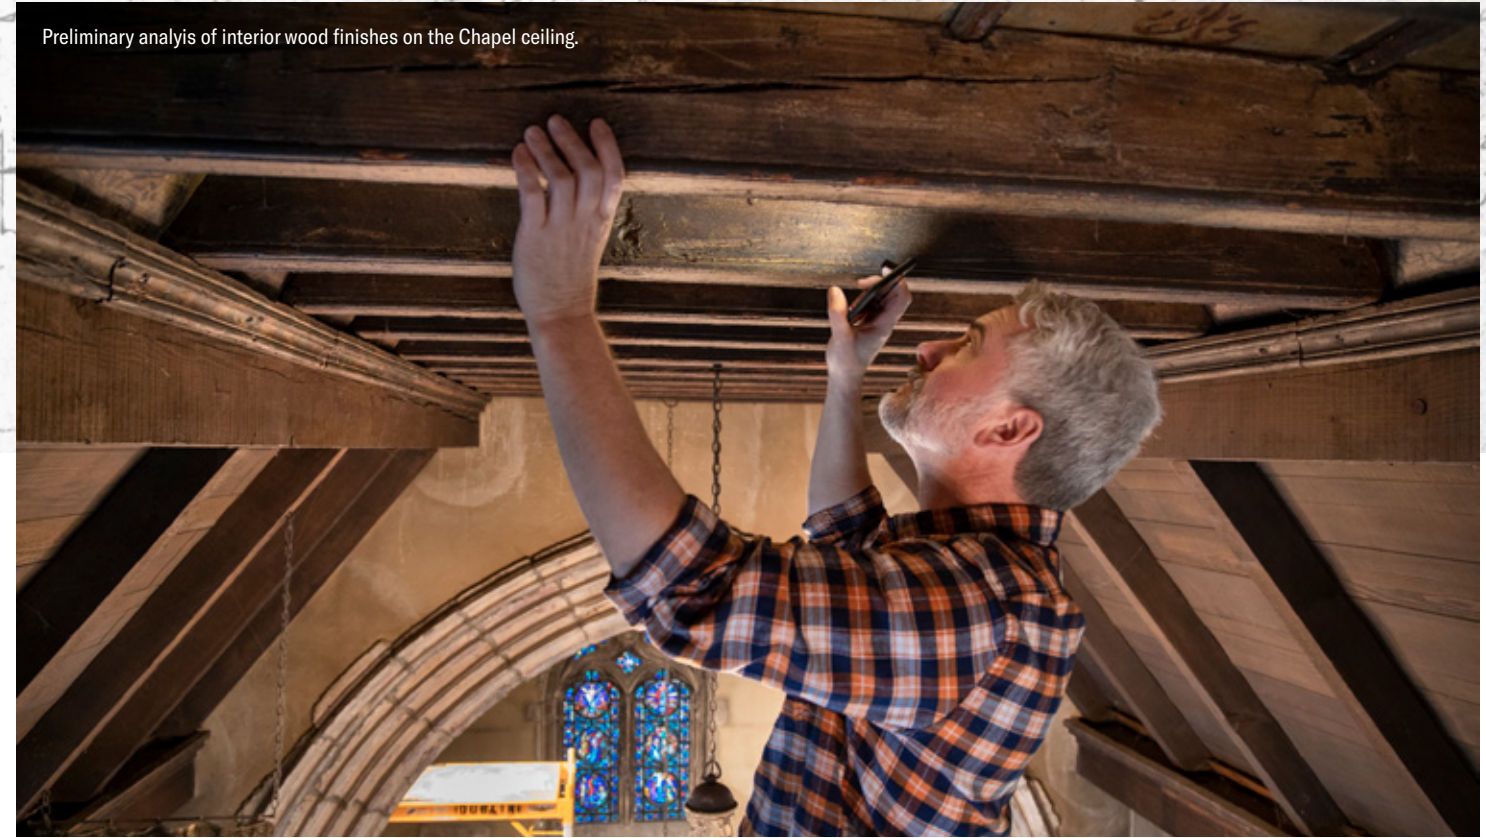
Preliminary analysis of interior wood finishes on the Chapel ceiling.

Painted wood elements on the Chapel ceiling date from the 16th Century and are a character defining feature of the interior. To ensure long term preservation of these finishes it is important to examine them carefully. Visual inspections help identify issues such as warped or spilt wood panels. A comprehensive evaluation not only requires physical assessment but also other methods such as laboratory analysis, which is currently ongoing. These efforts will help determine the best procedures for conservation.

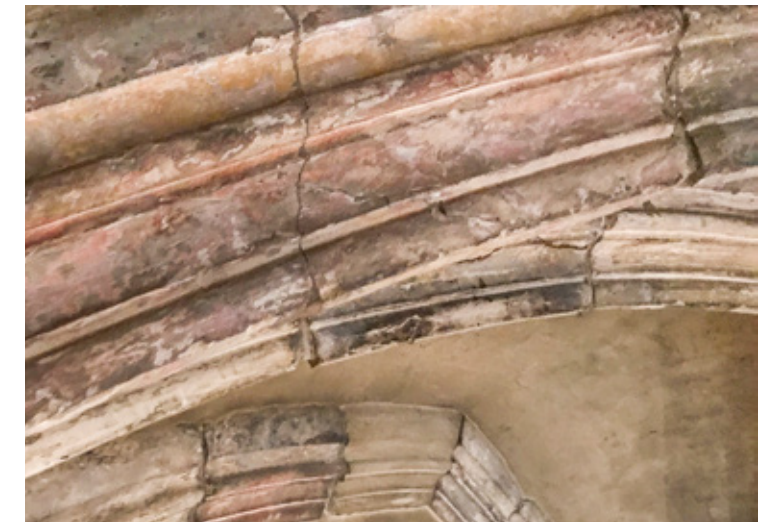
Certain areas of the interior stonework have remnants of historic paint. Examples of original Medieval polychrome painting on stone is rare. Our lab analysis work will look to identify if these are historic paint surfaces indicative of the time period.

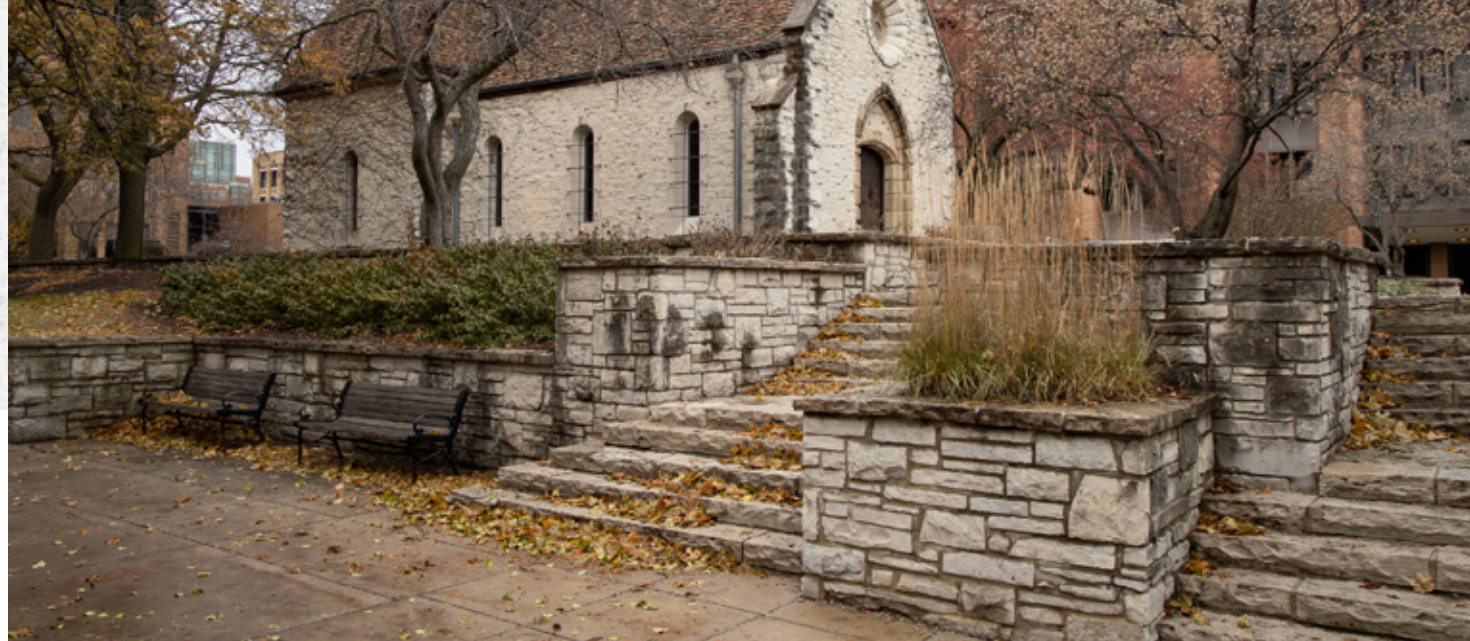
Existing site conditions require modification to improve accessibility, safety, and aesthetics. The bluestone paving around the Chapel and fountain is in poor condition, making the surface a trip hazard and non-compliant with ADA standards. Mortared stone walls need repair and tuck-pointing. There are moisture wicking issues with the vegetation along the perimeter of the chapel. Many trees have structural issues and are showing signs of decline, as well as having leaf disease / fungal problems. Many trees are planted close to the chapel and cause leaf debris and seeds to fall on the roof and into gutters.

Remove and replace bluestone paving with stone to match the newly installed Grotto paving. Repair mortared stone walls as needed. Replace steps and landings with new reinforced color-matched concrete. Add accessible pathways at the west and north site entries where grade allows for low impact improvements.

Remove old or compromised trees. Install new native tree species which are adaptable to site conditions and provide a more formal look to the chapel site and gardens. Existing gardens (shrubs, perennials, groundcovers) should be evaluated and potentially replaced and redesigned for the site as appropriate.

Provide new stone urns, planters and benches. The materials should be high quality natural or cultured stone and match appropriately to the architecture of the chapel.
